H-60 WIRING SYSTEM AWARENESS

PREVENTING WIRING SYSTEM FAILURE SAVES TIME, MONEY...

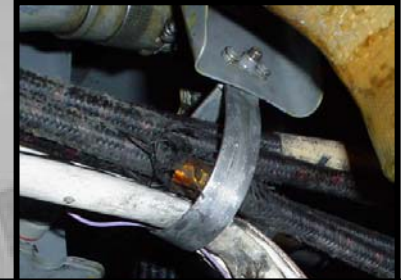
Silicone tape does not provide adequate chafe protection.

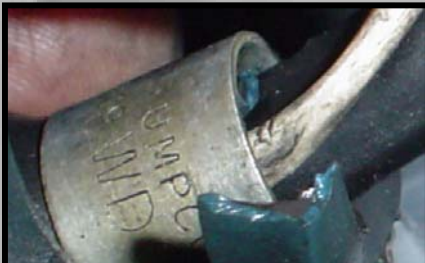
How much damage must be caused before clamps are replaced?

Deteriorated clamp chafing into unprotected wire.

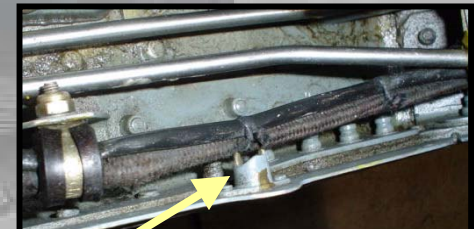
Unused connectors require proper protection/stowage.

RF cable chafing fastener receptacle.
